## High humidity dent repairs

Due to wide spread rock falls, an operator had various pipelines with dent damage. Across diameters ranging from NB 600mm to 50mm The structural and pressure containing serviceability of these lines required reinstating. Additionally the location had humidity over 90% and regular rain.

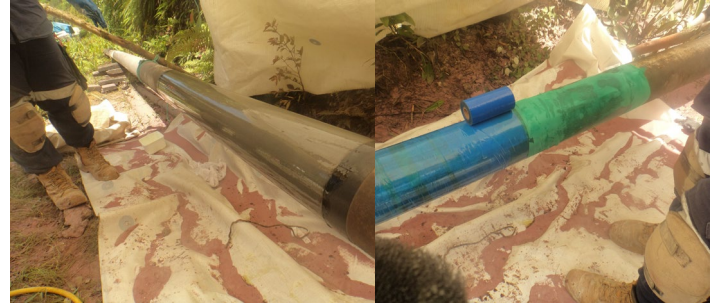
Profiling and consolidation

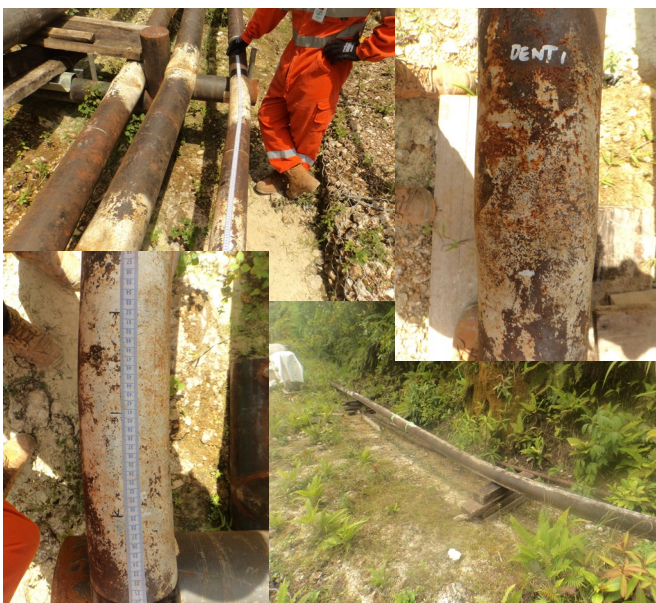
Repair locations

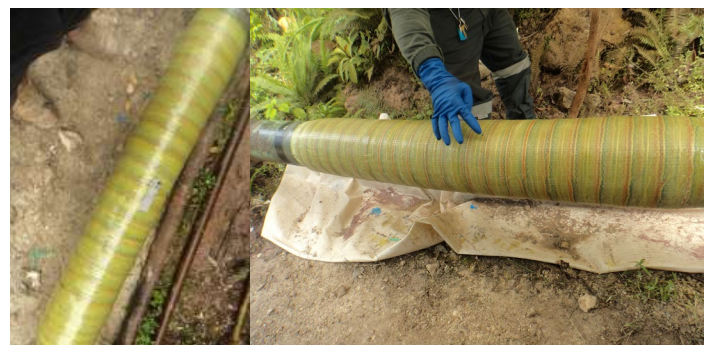
Completed repairs

- Technowrap subsea system was used so that humidity and rain did not delay the installation
- Works completed live without hot work
- 2k, glass fibre, was used to enable existing inspection systems to continue being used
- Designs updated immediately with information fed back from site during installation
- Supported by third party testing to verify design methodology
