Corrosion Under Pipe Support Repair

A rapid turn around with no shut down repair was required on a gas plant 80NB line. At the pipe support corrosion had occurred and an immediate repair was required that would provide a permanent repair solution.

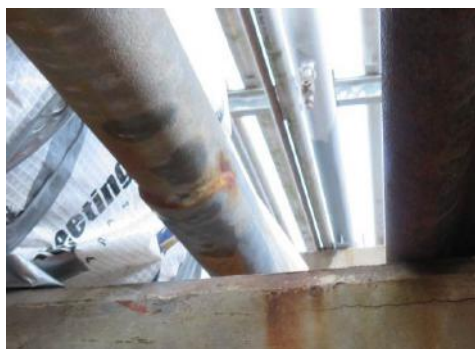
| Corrosion Type | External Corrosion at pipe support |
| Defect Details | 400mm x 100mm Designed for full section loss over 600mm through wall |

Defect Location

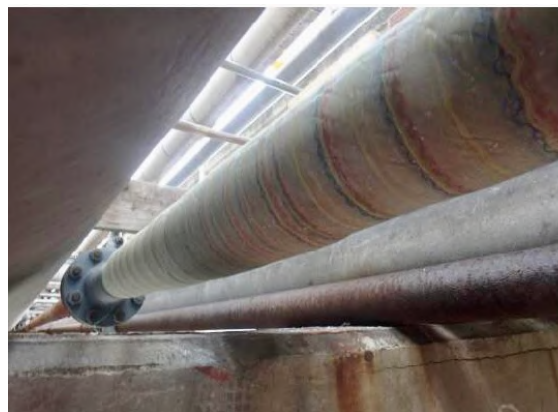
Technowrap installed

- Heat tapes were used for rapid control of cure, reducing down time
- Site crew able to provide surface preparation and Technowrap repair
- Full section loss design, no steel allowance for loads of leak sealing over 600mm section
- Stops any further external corrosion

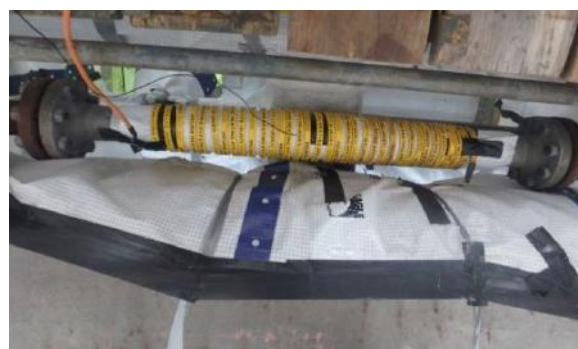
Final laminate being post cured with Heat Tapes
